**SERVICE
ENGINEERING
BULLETIN**

SB2184.1

Hydraulic Valve Lifters

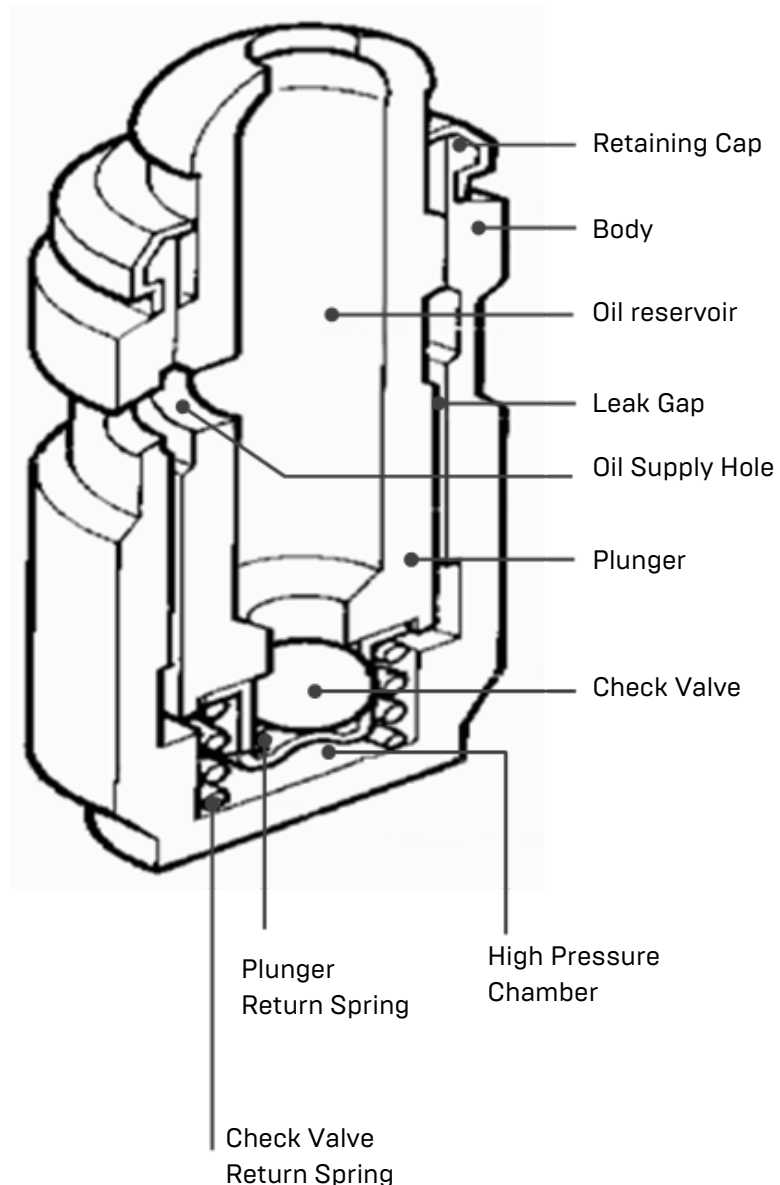
It is possible to strip down and reassemble most hydraulic lifters. These components have very fine tolerances and bedding-in takes place during use. It is important not to interchange the component parts with other lifters when carrying out strip down and reassembly on used lifters.

The most common problem encountered with hydraulic lifters is 'pump-up'. This condition occurs when the lifter over-extends. This sometimes prevents the valve from closing and results in piston to valve collision.

Weak or broken valve springs or over-revving the engine often causes this condition. However, foreign particles circulating in the lubrication oil can block the check valve inside the lifter with similar results.

Inspect the lifters both internally and externally for signs of wear or damage. In the case of dynamic lifters, measure the radius on camshaft contact face. If necessary, re-grind the contact face, taking care not to break through the surface hardness. Thoroughly clean the component parts of the lifters, re-assemble and perform a 'leak down test'.

If 'OE' leak-down specifications are unavailable then the general guide is that the plunger must return to its original position within 10 - 60 seconds of being compressed by 3.0mm / .125"
