# TROUBLE TRACER CHART VALVE TRAIN

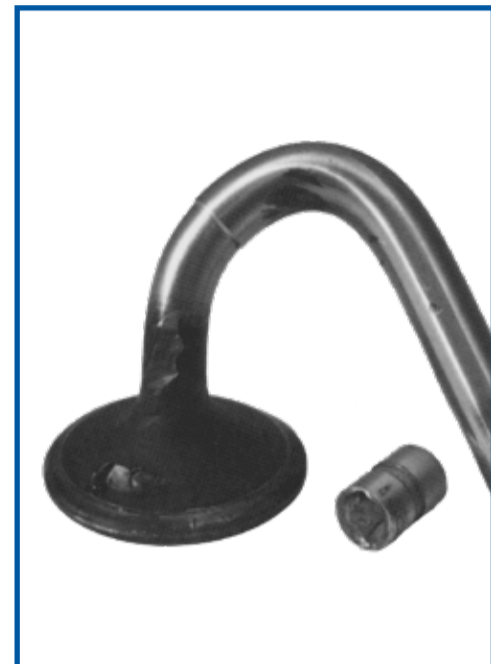
## Stem breakage through collet groove

**Symptom:** Excessive mechanical noise, bent stem and possible head detachment.  
**Cause:** Poor assembly allowing uneven loading. Poor handling, dropping etc. Bouncing the valve after fitting by hitting the tip with a hammer. Valve bounce from excessive seating velocity.  
**Remedy:** May not be possible due to extreme damage this failure can cause, however: Check seats, guides, springs, pistons and bores for damage and repair where necessary. Do not overspeed the engine.

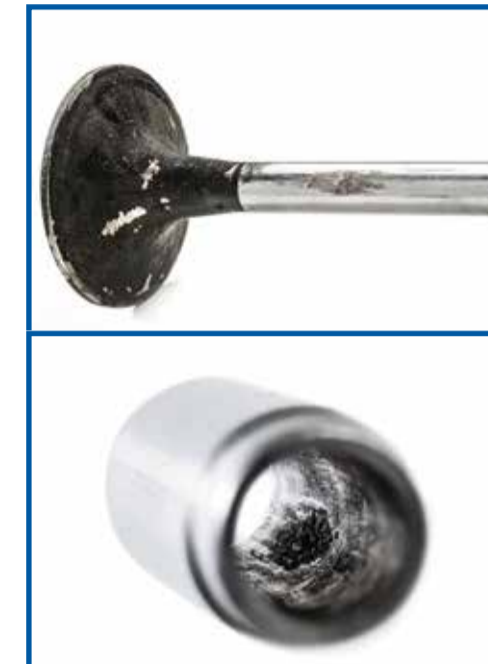
## Scuffed/sticking valve stem

**Symptom:** Poor performance due to low compression. Mechanical breakage due to sticking valves.  
**Cause:** Marginal lubrication from inadequate valve to stem clearance, causing scuffing or metal transfer. This may ream out the valve guide leading to the second cause, excessive oil from too great a clearance carbonising on the stem to cause sticking.  
**Remedy:** Ensure the valve stem to guide clearance is to specification. Ensure the correct valve stem seals have been used. Replace worn components where necessary.

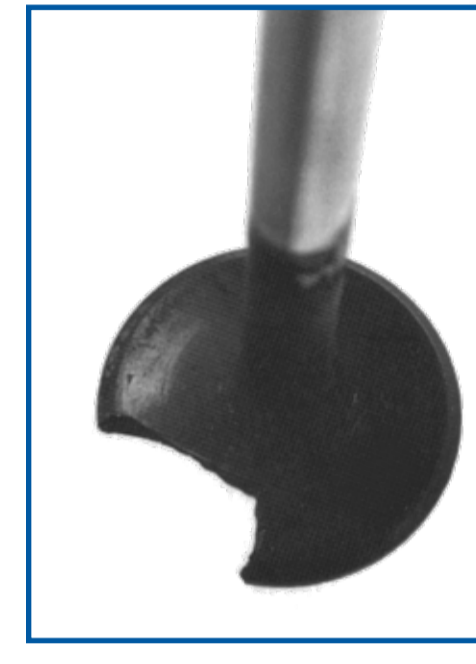
## Radial cracking of valve head, leading to a triangular segment breaking off

**Symptom:** Sudden mechanical noise. Rough running. Possible seizure.  
**Cause:** Poor temperature distribution across the valve head resulting in high tensile stresses in the rim, often combined with severe deflection due to abnormal combustion pressures and temperatures. Extreme thermal cycles, (continual sudden changing from full power to shut-down). Damage marks on the rim producing stress raisers. Mechanical overload from valve bounce.  
**Remedy:** Check the remaining valves for signs of cracking, replace where necessary. Ensure the correct valves have been used. Check engine settings, valve springs, guides and followers. Do not overspeed the engine.

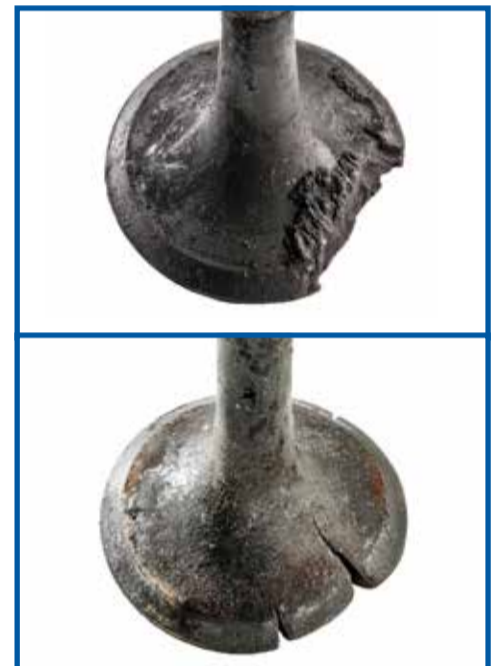
## "Gutter" burnt through valve rim

**Symptom:** Loss of power. Rough running.  
**Cause:** Valve clearance too small holding the valve off its seat. Sticking stem, poor/uneven seating or misalignment of the valve assembly. Overheating from pre-ignition. Excessive build up of carbon which flakes off the valve face to form a gas leakage path. Hard carbon particles peen into the seat surface until enough indentations line up to form a gas leakage path.  
**Remedy:** Ensure valve clearance is to specification. Check stem to guide clearance and for any misalignment of the valve assembly. Check engine timing, carburettor settings and injection timing.

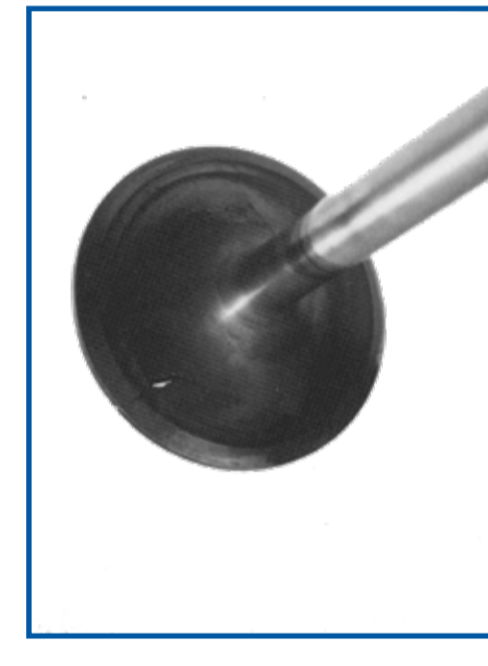
## Blow hole through valve head, starting from a radial crack

**Symptom:** Rough running. Loss of compression. Poor starting.  
**Cause:** Similar to a segmental breakage, but gas escapes through the crack and burns a hole. Extreme thermal cycles (continual sudden changing from full power to shut down). Damage marks on the rim producing stress raisers. Mechanical overload from valve bounce.  
**Remedy:** Check remaining valves for signs of cracking, replace where necessary. Ensure the correct valves have been used. Check engine settings, valve springs, guides and followers. Do not overspeed engine.

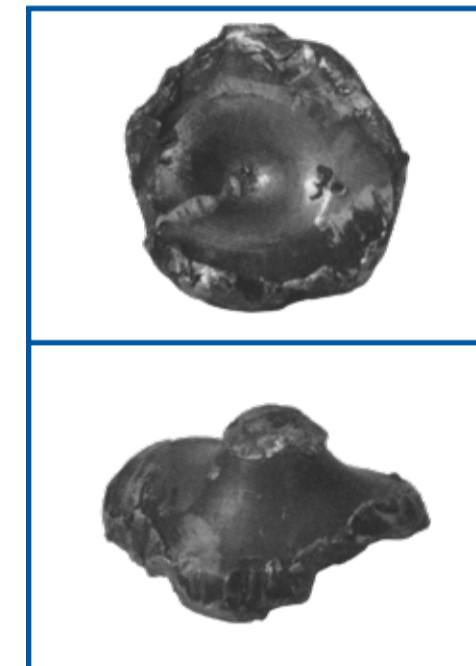
## Valve head breaking off stem

**Symptom:** Rough engine with sudden mechanical noise.  
**Cause:** Mechanical overload, such as seating velocity too high from excessive valve clearances. Valve bounce, valve to piston contact caused by overspeeding, weak or broken valve springs or sticking valve stem. Uneven seating due to misalignment or distorted valve.  
**Remedy:** May not be possible due to extreme damage this failure can cause, however: Check valve springs, guides and alignment and repair where necessary. Check seat guides, pistons and bores for damage. Reset the valve clearances.

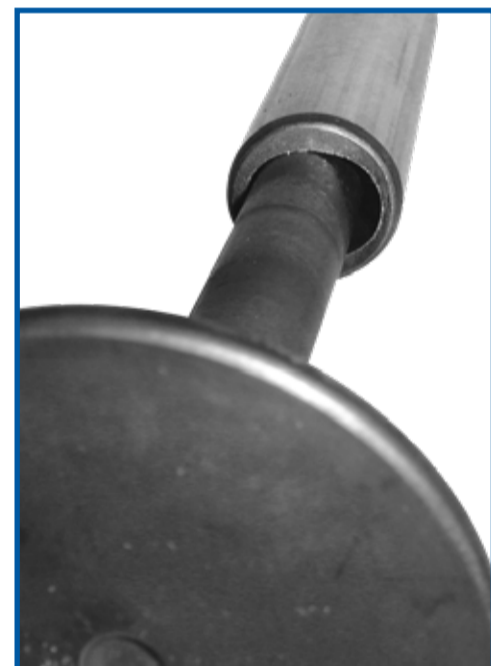
## Excessive valve stem and guide wear

**Symptom:** Valve gear noise, high oil consumption, exhaust smoke on initial start up.  
**Cause:** Too great or too small valve stem to guide clearance. Poor valve stem lubrication or ingress of dirt through the air intake system. It should be noted that the cause of this problem is not always obvious. Unless the cause is readily apparent, additional advice should be sought.  
**Remedy:** Ensure correct valve and guides are fitted. Check alignment, valve stem to guide clearances, valve stem seals and lubrication system.

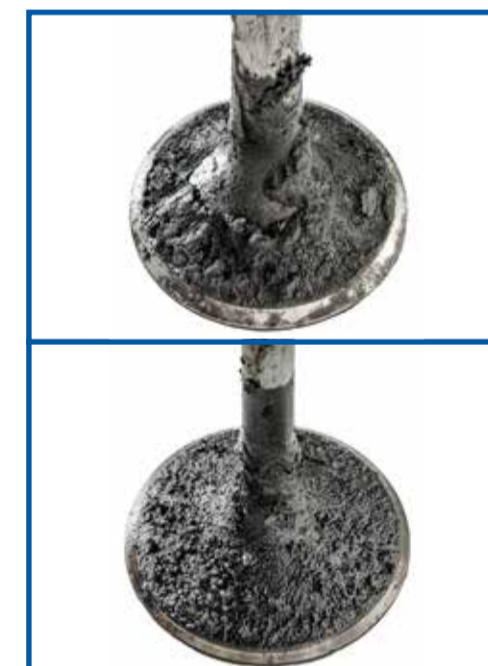
## Inlet valve underhead carbon build-up

**Symptom:** Poor starting. Loss of power. Blue smoke from exhaust (when throttle closed).  
**Cause:** Excessive clearance between valve stem and guide. Valve stem seal failure or wear. Excessive oil supply due to blocked drainage paths. Incorrect grade of lubricating oil used.  
**Remedy:** Check valve stems, guides and stem seals for wear and replace where necessary. Ensure there is no blockage in the engine drainage or breathing systems.

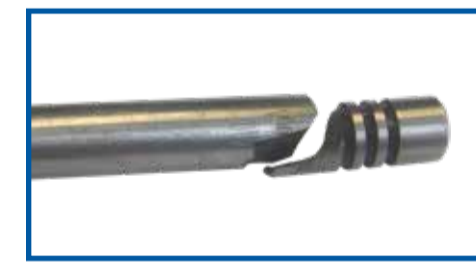
## Valve breakages -fracture at lower cotter groove

**Symptom:** Valve breakage shortly after cylinder head rebuild, during initial start-up or during test run.  
**Cause:** Over extension / "pump-up" of hydraulic lifters (photo 1). Incorrect seating of the valve spring to the head (photo 2). Engine over-speed or weak springs.  
**Remedy:** Where possible fit new hydraulic lifters with new valves. Ensure the engine block is thoroughly cleaned to remove all traces of debris. Take extreme care to seat all valve springs correctly in the recess of the cylinder head. Renew engine oil and replace oil and air filters.

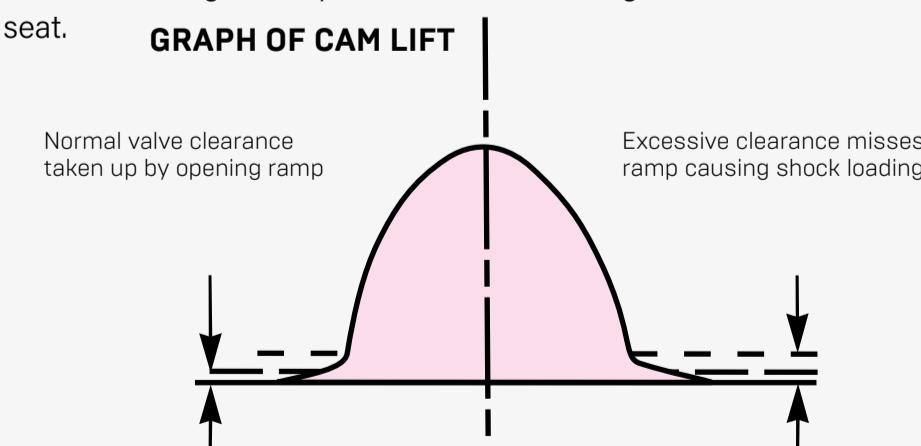
- Initial valve opening and final valve closing occurs very gently. Cam lobe profiles include lifting and lowering ramps to achieve this.
- Ensure the valve clearances are not too great to prevent the valve being hammered open or dropped onto its seat.

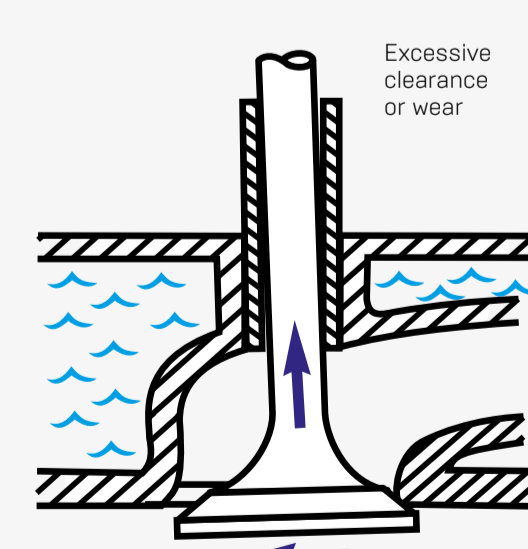
- The valve seat must be concentric with the valve guide. Any eccentricity that exists between the valve seat and guide will force the valve sideways.
- Excessive valve guide wear will occur as a result of this which can lead to a fatigue failure of the valve stem.

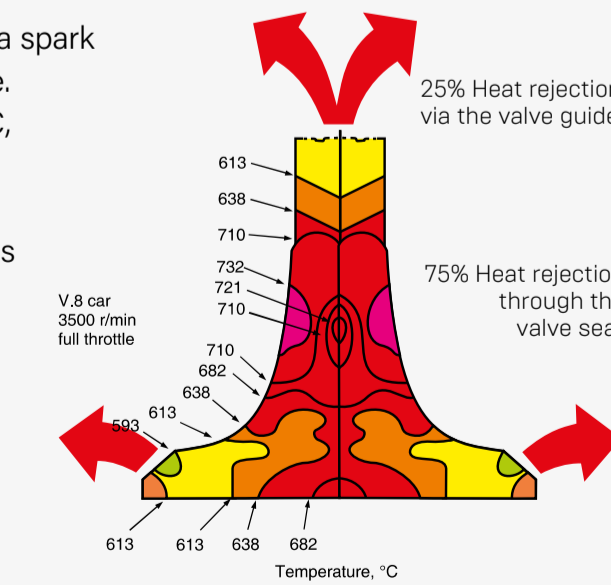
- Typical exhaust valve temperature distribution in a spark ignition engine. Figures are degrees in centigrade.
- An exhaust valve may operate at up to 800 °C, and 75% of its cooling is by transferring heat to the valve seat.
  - Ensure the valve seat contact is correct and as specified by the engine manufacturer.
